# COMPARATIVE EVALUATION STUDY OF ON-LINE CAMERA-BASED WEB INSPECTION SYSTEMS

# **AF&PA/MTC Comparative Evaluation Study of On-line Camera-based Web Inspection Systems**

## **Evaluation of the R.K.B.® OPTO-ELECTRONICS, INC.**

### **MODEL 3030® OPTOMIZER® Camera-based Video Web Inspection System for Holes, Flaws, Coating Streaks and/or Scratches**

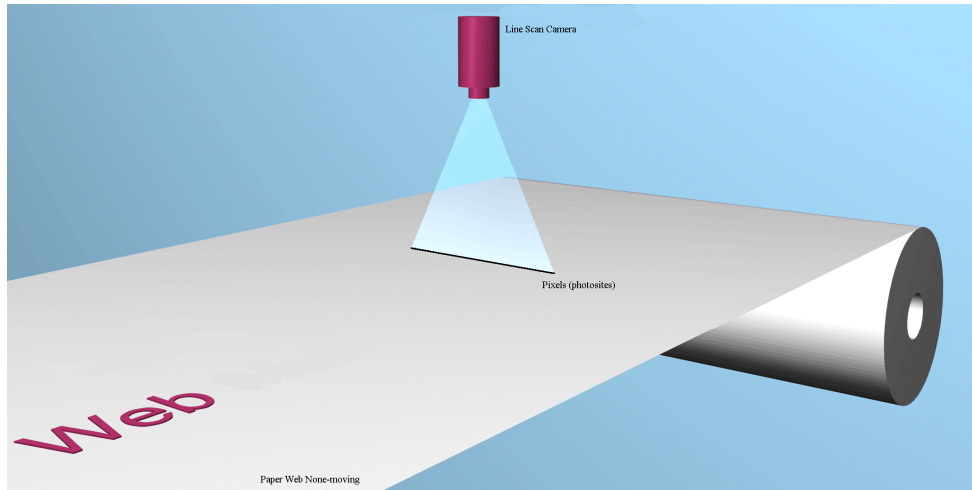
**Figure 3 - Cross machine pixel resolution on a stationary web or "Static Resolution"**

CCD camera based web inspection suppliers typically define system resolutions (or minimum defect size) as the field of view (FOV) per sensor in the cross machine direction divided by the number of pixels contained within that sensor. That means a 2048 pixel linear array camera viewing 20 inches (50.8 cm) of material in the cross machine direction should have a resolution of slightly less than 10 thousandths of one inch (0.254 mm) or the size of the pixel resolution in the cross machine direction (Table 1).

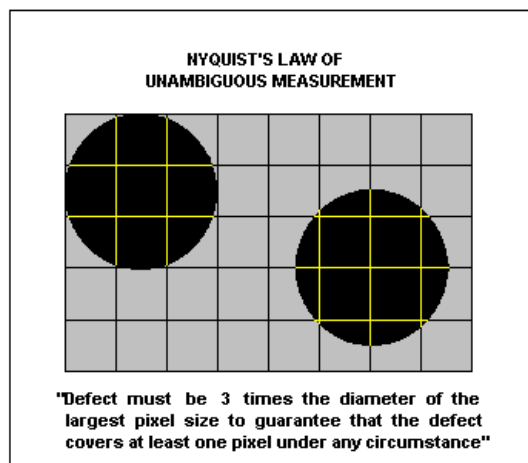
Another factor, which has a direct affect on system resolution capability, is Nyquist Theorem. In 1928, Henry Nyquist determined that, when sampling at a given rate, the highest frequency that can appear in the sampled signal is half the sampling frequency. If the sampled signal contains frequencies higher than half the sampling frequency (higher than 4 kHz when sampling at 8 kHz as is the case for  $\mu$ -law), these higher frequencies will appear folded down to below half the sampling frequency when the signal is reconstructed. This is the Aliasing problem. This problem, commonly referred to as Nyquist's Law of Unambiguous Detection Measurement, states that the "Defect or event being inspected must be 3 times the diameter of the actual pixel coverage size to guarantee that the defect fault or event covers at least one full pixel under any circumstance (Figure 4).

**Figure 4 – Nyquist's Law of Unambiguous Measurement**

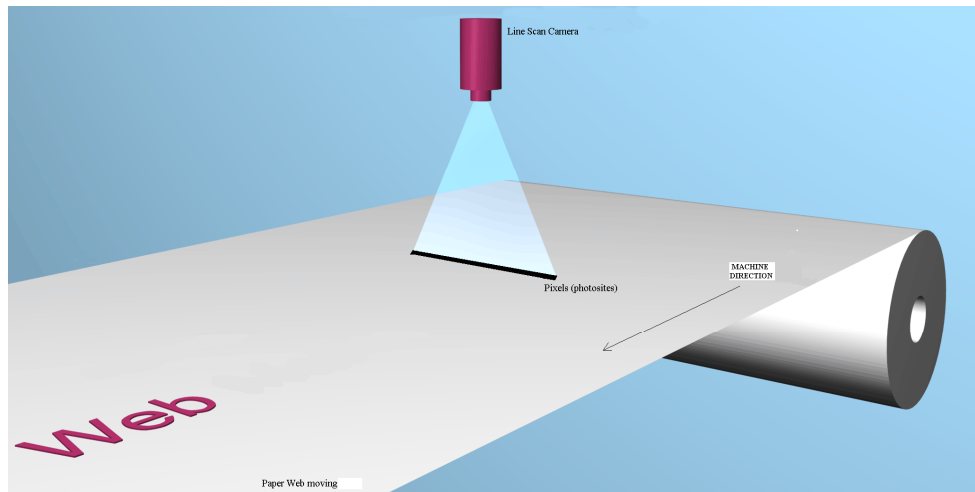
**Figure 5** – Machine Direction pixel resolution on a moving web or “*Dynamic Resolution*”

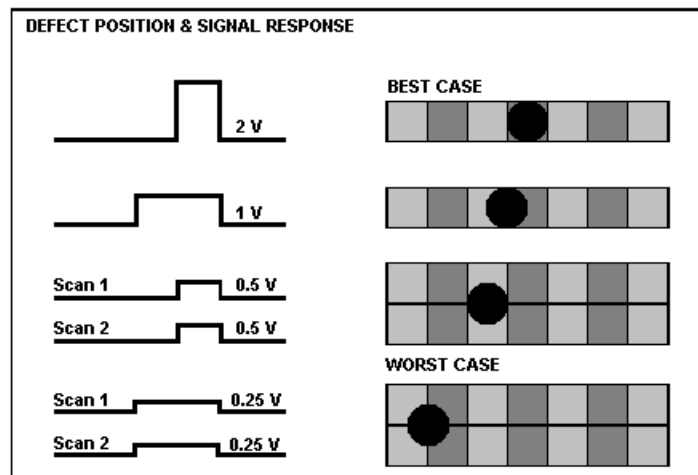
Every CCD camera-based solution, no matter what CCD pixel array you use, has a best case and worst-case resolution scenario. If a defect fault or event covers the full pixel, either in a static environment or dynamic environment, the voltage signal output is at its highest optimum level or full modulation (**best case**). However, in reality one has to deal with machine process speed, various energy levels, and web tension control fluctuations, web wander, shrinkage and other variables generally not present during inspection in a static environment. All these factors can seriously alter your best case resolution scenario. Another “real-world” issue that most suppliers neglect to consider is the relative timing between a defect fault or event during any one particular CCD pixel array scan. Unfortunately, reality being such as it is, many defect faults or events cover only a portion of the full pixel during any one scan and the resultant voltage signal output is reduced from its optimum level or modulation. It is quite feasible that a defect fault or event could fall on a quarter of the pixel coverage providing only a 25% optimum voltage level output or modulation (**worse case**). Refer to Figure 6 for a depiction of the best case and worse case signal responses.

**Figure 6 – Best Case/Worse Case Signal and Defect Resolution Response**

As seen above in *Figure 6*, when a defect fault during a CCD linear array scan lands completely within the pixel, the resultant voltage level output is at full modulation or 100%. However, when the defect fault lands on the crosshairs, so to speak, upon completion of one scan and initiation of another, approximately  $\frac{1}{4}$  of the defect fault is detected resulting in  $\frac{1}{4}$  modulation or 25%. This phenomenon, which can reduce the ability of the detection process, can be avoided if proper and direct care is taken prior to manufacturing a system to take the possibility of decrease modulation into account. Additionally, the reduction in defect modulation dramatically gets worse when machine process speeds are increased. Of course, lighting which is another factor, can play an important roll if you cannot generate enough energy to run the CCD array at optimum scan rates.

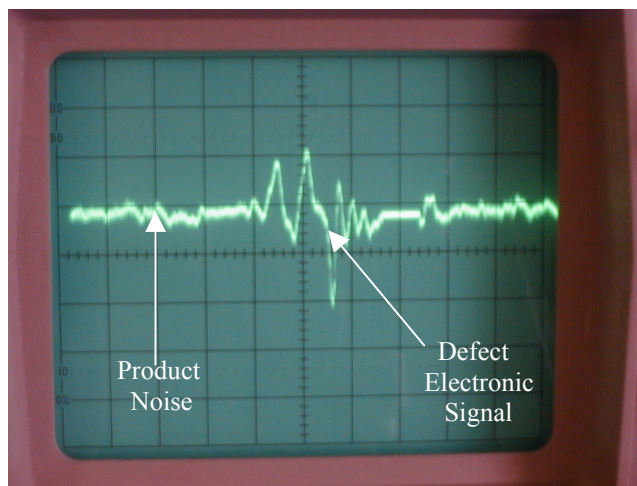
As with all inspection solutions, the resultant output obtained from the electronic processing modules is an electronic signal. In this signal you have what we call noise (generated by the product itself). From that noise, you have discrete voltage spikes that may or may not be defect faults (*Figure 7*). This overall signal is referred to as the signal to noise ratio. In most cases, one would want a signal to noise ratio of 3:1 or better, with 3 representing the defect and 1 representing the noise. However, since reality shows that defects do not necessarily land and cover a full pixel in any given scan, as shown in *Figure 6*, the resultant voltage levels become lower and more difficult to discern. This phenomenon is especially true with subtle dirt and coating streaks/scratches. Under a static environment, all sensors should produce similar results with similar outputs. However, when machine speed is applied to the equation, the defect may not provide the optimum modulation during detection to provide a reliable output signal. This has been demonstrated in the paper industry time and time again. RKB Commonly hears from papermakers that the units they currently use are so sensitive and see everything that they have to reduce the detection threshold. This was a common statement made when Laser Systems had there hey day. What is actually occurring is that the defect electronic signal is not strong enough nor contains significant characteristic changes for the inspection system to pick out the defect from the random noise. As such, the inspection system is rendered for all intent and purpose, useless.

**Figure 7 - Signal to Noise Level of Defect Vs Material**

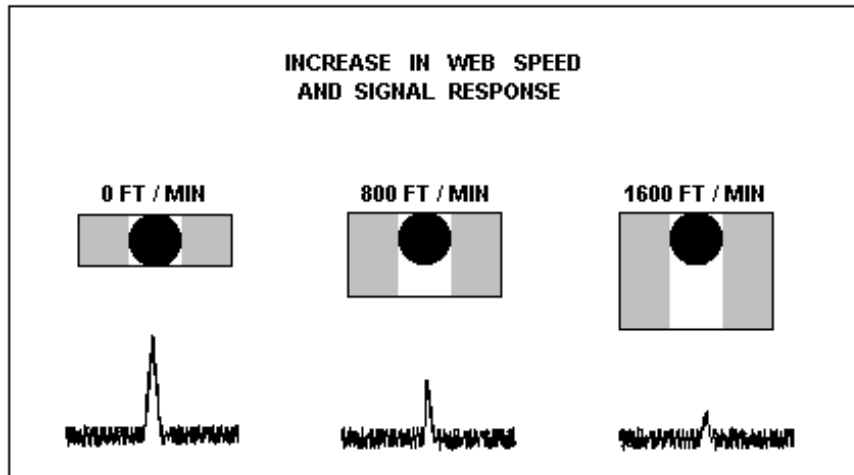
For example, lets take a 1/32" (0.8mm) black spot on a white paper. Apply machine speed to the paper web and increase said speed accordingly. As you can see in *Figure 8*, the detection capability of the CCD linear array chip set deteriorates due to the fact that the defect fault or event is no longer falling or covering one full pixel, but only part of a pixel during any given scan. Therefore, the modulation of the defect electronically starts to decrease until it become completely immersed within the noise level of the product material itself.

Figure 8 – Effects of web speed on the defect signal to noise ratio

Another phenomena that hinders reliable detection with CCD's, unless taken into account, is pixel stretch. Again, as you can see in *Figure 8* above, as you increase the machine speed, the machine direction resolution per pixel also increases or stretches. This affect causes the total area covered by the pixel to increase. Therefore, if you are looking at a 1/32" (0.8mm) black spot that covers a full pixel in static mode (left view in *Figure 8*), the same size spot will cover less of the pixel as machine speed increases until the modulation level of the voltage signal decreases to the point of non-detection (right side view in *Figure 8*). Now, take a white colored streak on white-coated paper and apply the same principal. Not only does the contrast level significantly decrease, but streak detection no longer can be done using line scanning technology as there is no way of being able to bring the subtle defect out of the noise level if your pixel coverage is, lets say 2mm wide by 10 mm line and your fault is only 5% or 10% of that coverage.

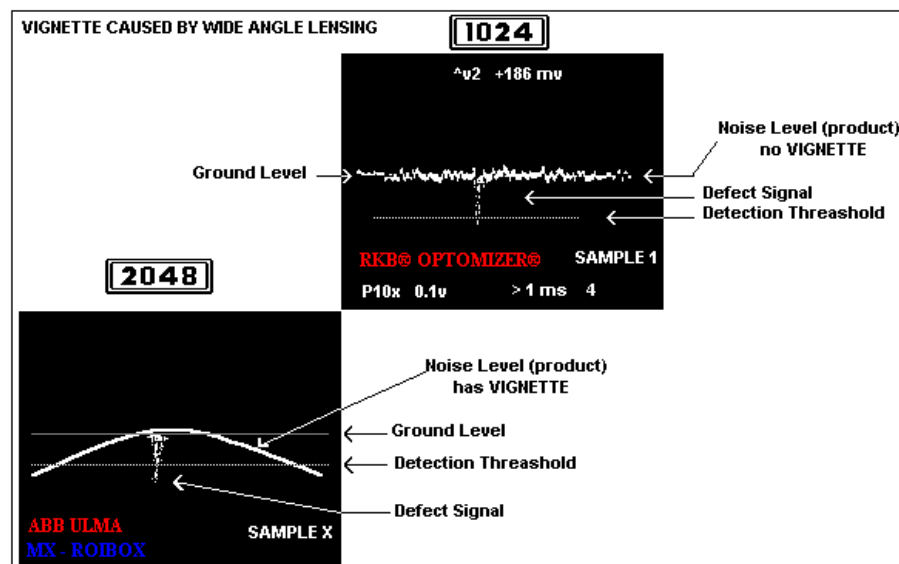
Earlier we mentioned that wide angle lenses also affects reliable detection. The main reason why suppliers of inspection systems would use this type of lens is to facilitate the use of as few sensors as possible, keeping costs down while maintaining profit margin. Although some applications would require the use of wide-angle lenses, main stream paper inspection is not one of them. Utilizing wide-angle lenses creates Vignette (*Figure 9*). Vignette is defined as "an image that shades off gradually into the surrounding background."

Figure 9 - Vignette Affect on Electronic Signal resulting from Wide Angle Lensing

Vignette applied to the electronic output signal of a paper defect fault or event, the defect eventually fades off into the noise level of the product material itself seriously degrading the detection systems capabilities for reliable, accurate and consistent detection. This becomes more apparent towards the outer fields of view of the sensors. It is RKB's opinion, although commonly used in our industry by others, that wide-angle lenses sacrifices the ability of the detection system to perform for the customer as intended. As seen in figure 9, the top oscilloscope representation shows the RKB CCD solution that is designed without the use of wide angle lenses, thus NO VIGNETTE phenomena affects detection reliability. The bottom picture shows what happens when wide-angle lenses are put in place to reduce the number of sensors required to do the job. The result, serious vignette problems exist.

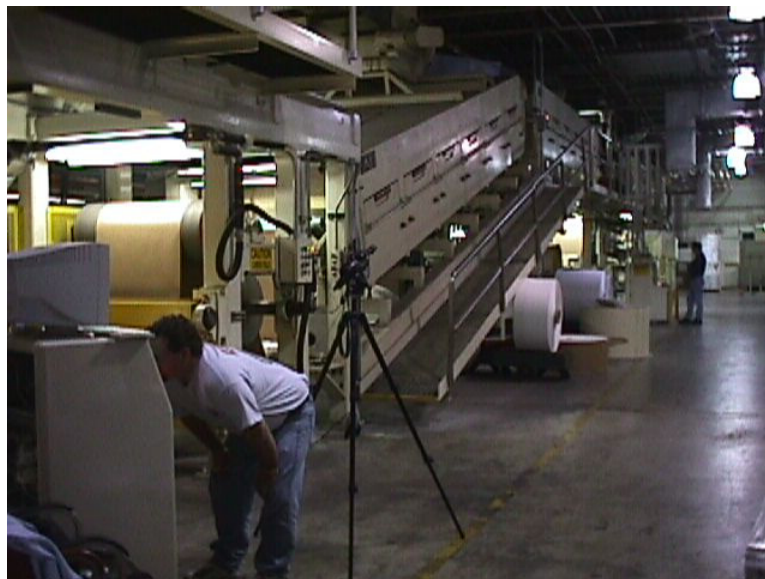
**Figure 10 – Pilot Coater Mill Environment**

The production machine in which the trial evaluations were conducted was the pilot coater machine located at Appleton Papers, Inc., Appleton, Wisconsin, USA. The machine is located in a separate building away from many environmental conditions that normally are present in the mill. The climate was very clean and dry (Figure 10). All products provided were pre-manufactured thus eliminating the need to actually use coaters and dryers. Vibration from the machine was minimal and ambient light had no affect.

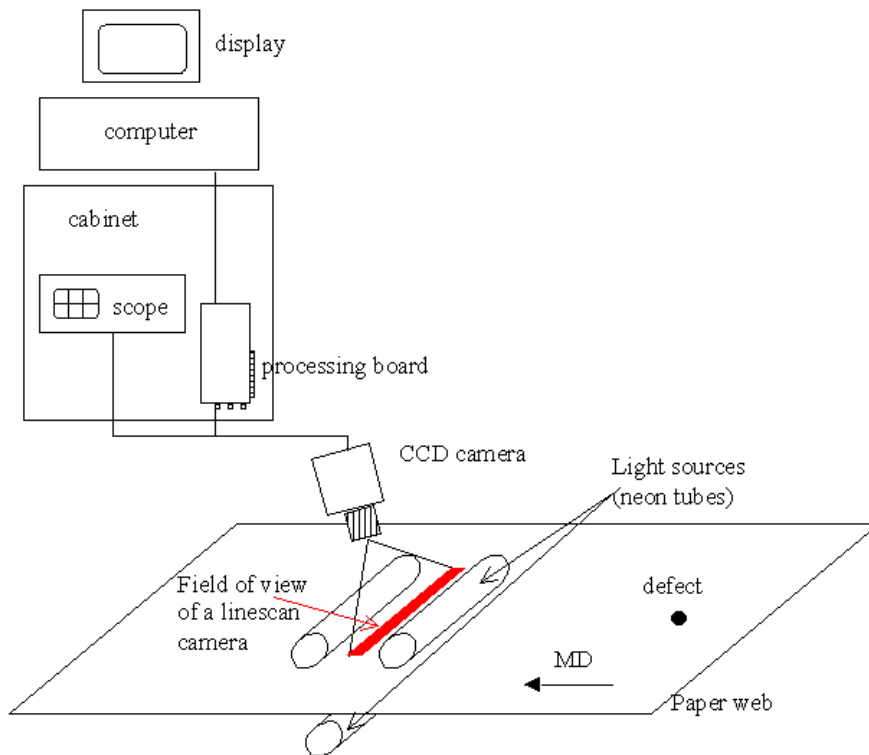
The model machine evaluated by the IPST and provided by RKB was their Model 3030® CCD Camera-based Video Web Inspection System with a true Microsoft Windows NT® environment. The machine had two configurations, one for discrete defects such as small dirt and one for subtle continuous defects such as coating streaks. A schematic of the system used for discrete defect detection at Appleton Papers is described in figure 11.

**Figure 11 - Diagram of RKB 3030 for discrete defect detection**

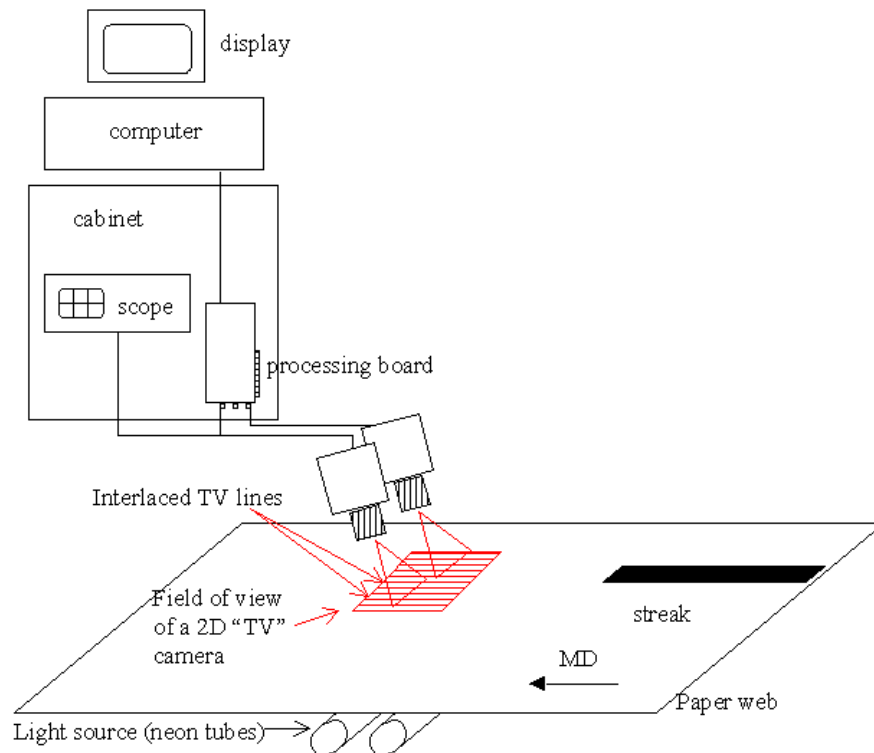
A schematic of the system used for subtle continuous defects such as coating streak detection, using the same frame, cabinet, electronic processing techniques and computer, but different sensors and lighting techniques, is shown hereafter (Figure 12):

**Figure 12 - Diagram of RKB 3030 for subtle continuous defect detection**

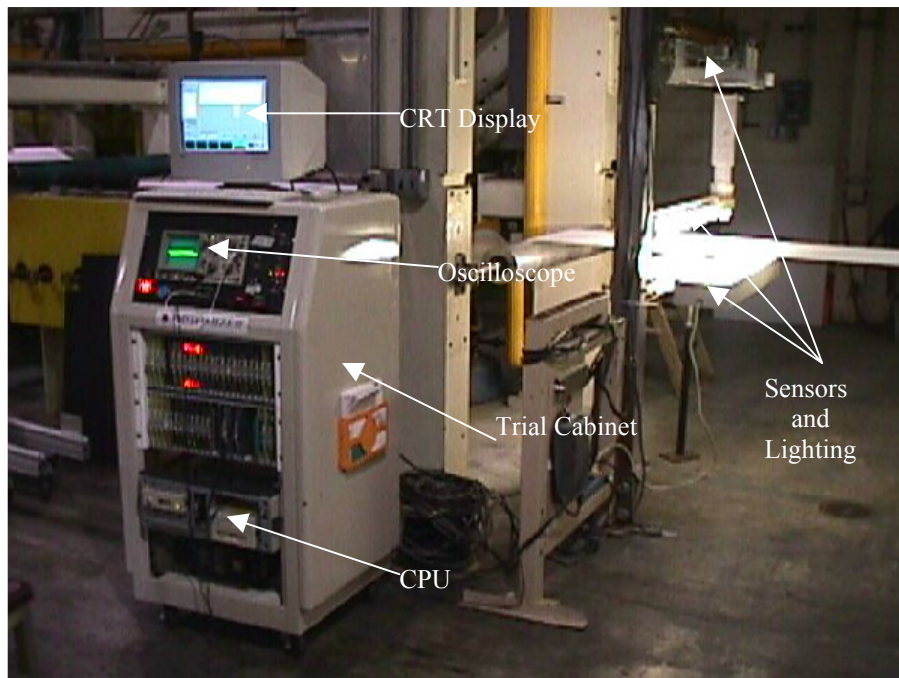
Figures 13, 14 and 15 show the control, sensor, lighting and interface sub-units of the Model 3030 in greater detail. These sub-units are designed with flexibility in that, they can deal with the detection of holes only, dirt only, hole/dirt, streaks only or all defects that can occur during the process of coated and non-coated material manufacturing. The neon tubes and the sensors are attached on the same frame.

**Figure 13 - General view of RKB Model 3030 used for evaluation in Appleton**

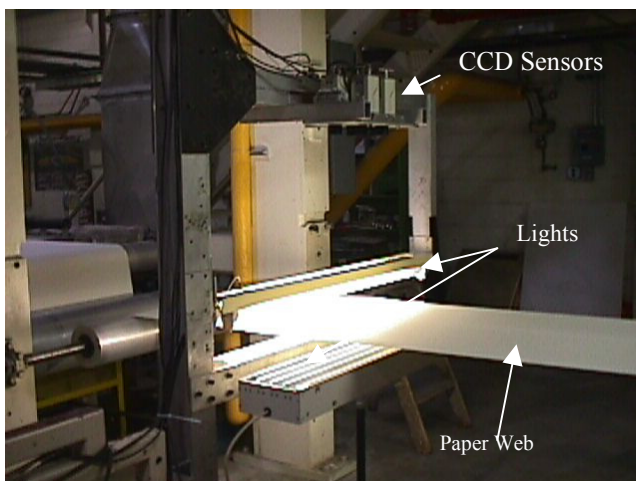
**Figure 14 - View of frame support, lighting and sensors**

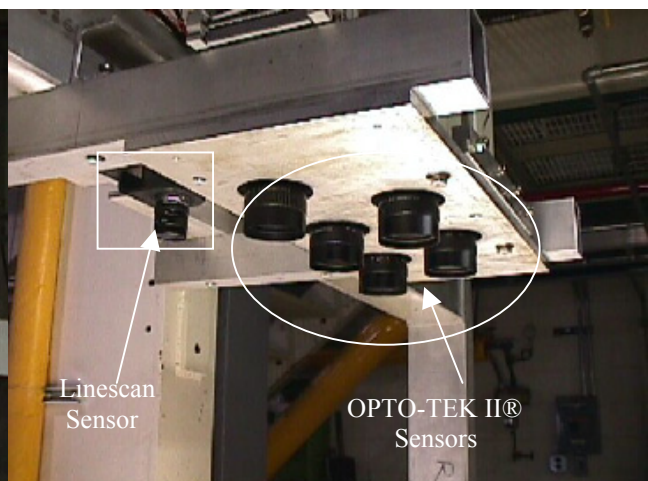
**Figure 15 – View of Linescan & OPTO-TEK**

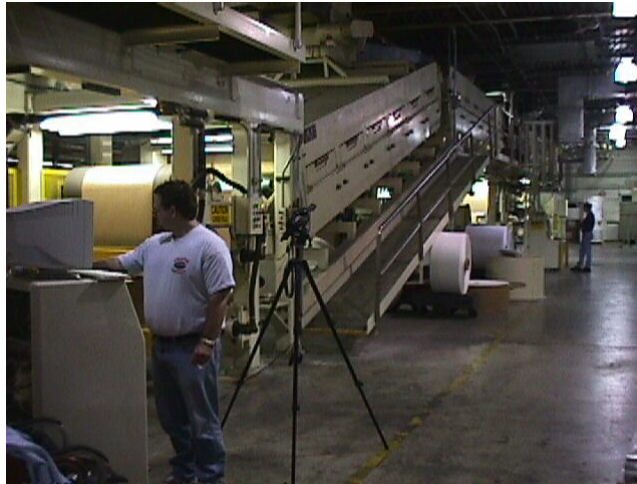
Figure 16 shows the location along the line of the pilot coater where the measurements were taken. At this location the web is horizontal at 1 meter above the ground and perpendicular to the optical axis of the cameras. The location is close to the end of the line.

**Figure 14 - Partial View of Pilot Coater Line. RKB Model 3030 was installed close to the take up reel. Paper is moving towards the left of this picture.**

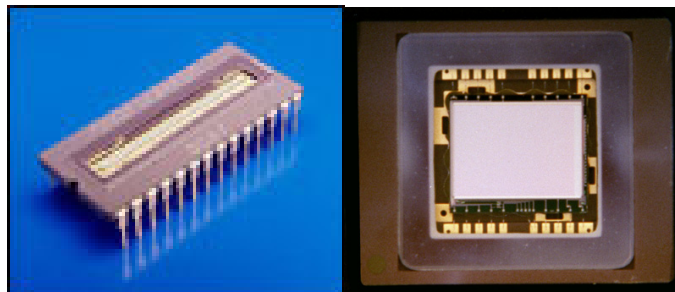
Regarding the directives set forth by the IPST, RKB modified their existing demonstration sensing head assembly around their Opto-Tek I™ (Figure 17) and Opto-Tek II™ (Figure 18) technology with a specific field of view per sensor to achieve the defect detection specifications as submitted by the IPST. The line scan camera, in this application, used 3 special very high output (VHO) neon tubes for the light source, 2 on top of the web in a reflection configuration to facilitate spot detection and one on the bottom side of the web in a transmissive configuration to facilitate hole detection. The distance from the line scan camera to the surface of the web was 27 inches (686 mm). The field of view (length of the line scanned cross machine direction) was 13.5 inches (343 mm). The sensor contained 1024 pixels that provides a scan rate twice as fast as a 2048 pixel line scan sensor (industry standard). The field of view was slightly less than the total width of the web (30 inches; (76.2 cm)) as RKB used only one line scan sensor for this evaluation due to the evaluation study defect specification and time constraints in providing equipment for the designated evaluation date.

**Figure 17 - OPTO-TEK I®**

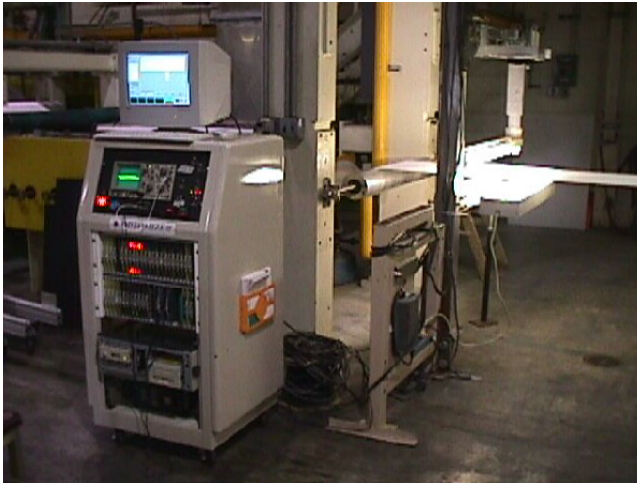
**Figure 16 - System on Pilot Coater Machine**

The RKB Model 3030 CCD Camera Video Web Inspection System (Figure 20) was placed on the pilot coater machine (Figure 21) at the Appleton Papers, Inc., Research & Development, Pilot Coater Machine. The coater was designed to accept paper widths up to 30" wide and could be operated up to full production speeds similar to that of actual production machines found throughout the paper industry. Companies that committed themselves to the interest of this study and provided the process machinery and/or material rolls for evaluation were Appleton Papers Co., International Paper Co., Longview Fiber Co., and Weyerhaeuser Paper Co. The material rolls provided contained numerous defects from oil spots, dirt to coating streaks and scratches. All autonomous (discrete) defects provided were supplied by the previously listed paper companies with the exception of the calibrated spot defects that were made and submitted by the IPST. The evaluation period was set to begin Monday, November 8<sup>th</sup> and would run to Friday, November 12<sup>th</sup>, 1999. Monday was designated for equipment installation and setup. Wednesday, November 10<sup>th</sup> was designated for coating streak detection (refer to Table 11).

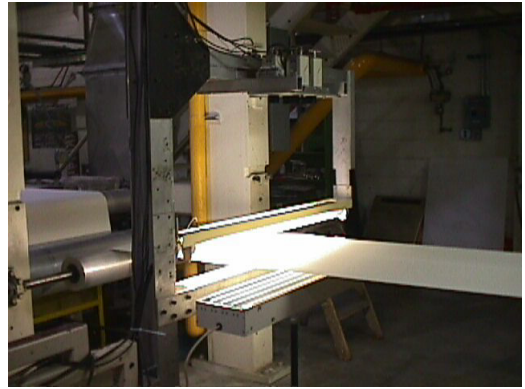
The demonstration equipment was set up to view holes, spots and coating scratches. The system inspection "C" frame was placed on the pilot coater just prior to the take up reel and aligned between the calender and mount hope roll. Inspection sensors were placed above the paper web. The light source assemblies were positioned above and below the paper web approximately one to two inches from the sheet (Figure 22). The placement of the sensors allowed for an eight-inch (20.32-cm) field of view per sensor for scratch detection and 13.5 inches (34.29 cm) for hole and spot detection. RKB adjusted the sensitivity of the system so that it was set at approximately a 2:1 signal to noise ratio for scratches and a 3:1 signal to noise (Figure 23) for holes and spots. Adjusting the signal to noise ratio or detection threshold will eliminate the potential false signals that can be generated by the product noise. The IPST provided various rolls of paper from coated to newsprint for evaluation. Since all products supplied already contained defect faults, there was no need to activate the actual coating station or dryers on the pilot machine. Pilot coater speed was checked and verified to run between 2500 fpm (762 m/min) and 5000 fpm (1524 m/min) per IPST specification. Defects of various sizes were provided and pre existent. Each material roll will be tested two to three times in the same direction and placement to verify repeatability.

**Figure 17 - Placement of lighting across pilot coater and paper web**

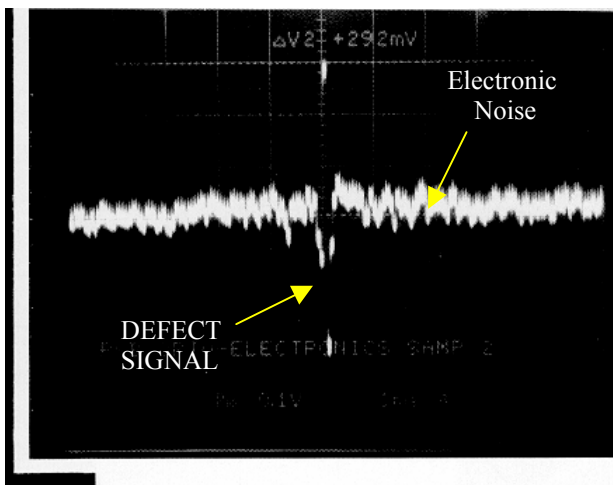
**Figure 18 - Signal to Noise Ratio**

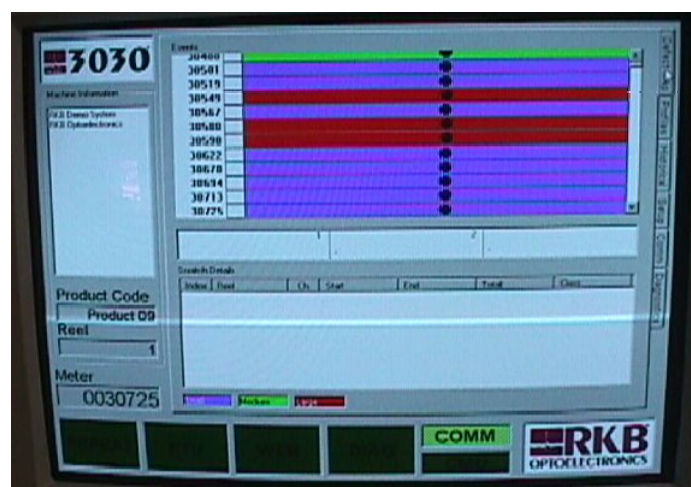
**Figure 21 - View of the CRT; Real Time Defect Mapping during the 33-lb Linerboard Export Evaluation**

The IPST observed much more dark spot detection's than that of holes and light spots in this grade as expected due to the basis weight and fiber distribution of this grade. Figure 26 depicts the real time mapping function of this run. The colored bars represent the size of the defect. The black circle in the middle of the color bar represents spot type defect (white circle or open circle represents a hole type fault). The color blue represents small, green is medium and red is large. The number on the left side of the mapping screen is footage indicating the machine direction location of the defect. The cross machine direction is determined by many factors in the production system and can be arranged by pixel, camera, group of cameras, etc. In this evaluation, since we were looking at such a small cross direction area, the camera itself represented CD. The roll of material was rewound for preparation for the second run.

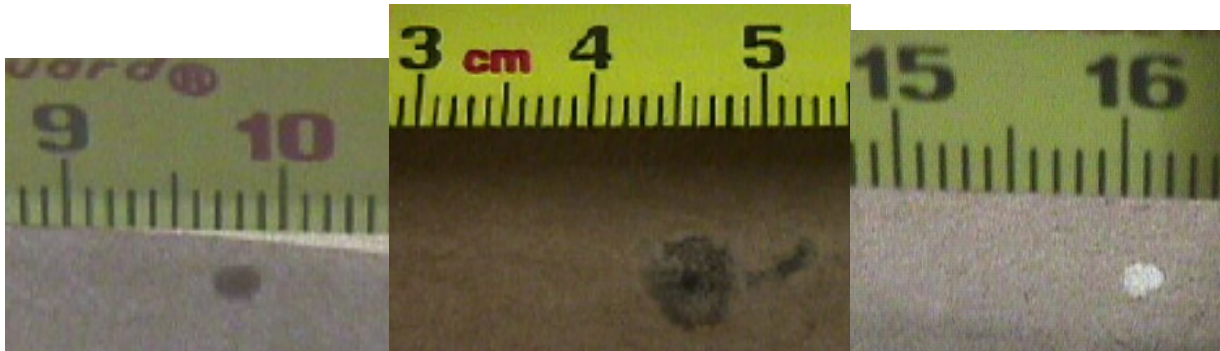
**Figure 28 – Pictures of defects detected at production speed during the 33-lb Linerboard Export Test. Defects include a light spot, oil and type of scale**

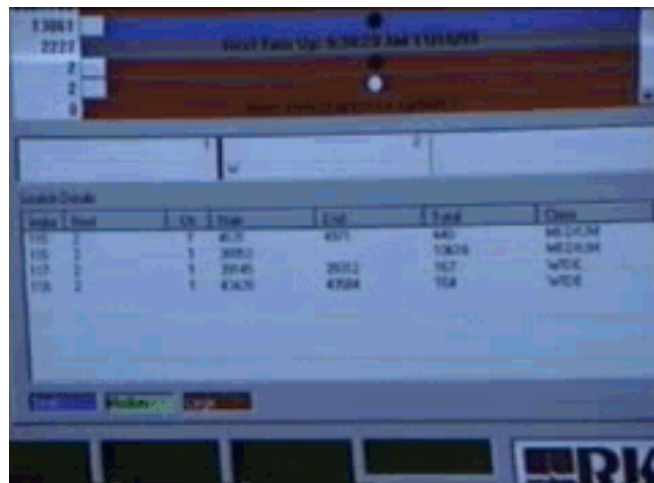
The test data and evaluation indicated that the unit was setup correctly and no apparent adjustments were required or performed. The defection threshold for activation of streak defects was set at <0.75 volts for narrow, 0.75 volts to 1.8 volts for medium and 2.0 volts for large. The unit indicated streak detection and was verified not only by the systems software, but by a small Sony TV monitor that is included with part of the unit for visualization. Additionally observed by IPST personnel were two peaks on the oscilloscope (standard equipment with all RKB inspection systems) delimiting the boundaries of the defect. This roll contained a splice where the web material was spliced after a possible web break prior to receiving the roll. As a result, the streak position changed during the run and was observed and picked up by the other sensor and verified via the oscilloscope and computer screen. The streak that was previously under camera one at 80 mm from the left edge of the web moved under camera two just after the splice. The width of the coating streak was a few millimeters in width and varied in width along the machine direction and duration (Figure 31). IPST, Appleton and RKB personnel visually saw the streak defect and were able to correlate the defect to the software data logging. It was also verified that the streak varied in width at times and also completely disappeared at points and then re-appeared.

**Figure 23 - Mapping and Text Display of Coating Streak during Choctaw Matter trial**

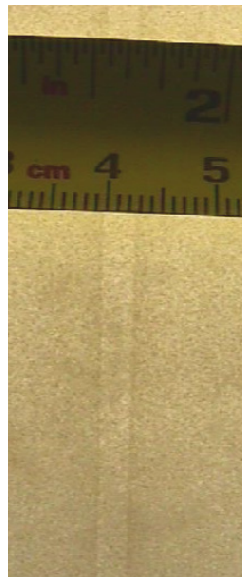
Again, as in the second run, the coating streak was detected and specified correctly (Figure 31). In this case, the product was not rewound thus the coated side faced the sensor unlike the second run. As with the second run, IPST personnel observed it, the streak jumped from camera to camera just after the splice. In this case, it jumped from camera two to camera one. Upon completion of the test, the roll was taken away and IPST started preparation for the next coated grade, Accolade Gloss Roll A.

**Figure 24 - Picture of a coating streak detected by the RKB Model 3030 during the Choctaw Matter Roll A evaluation**

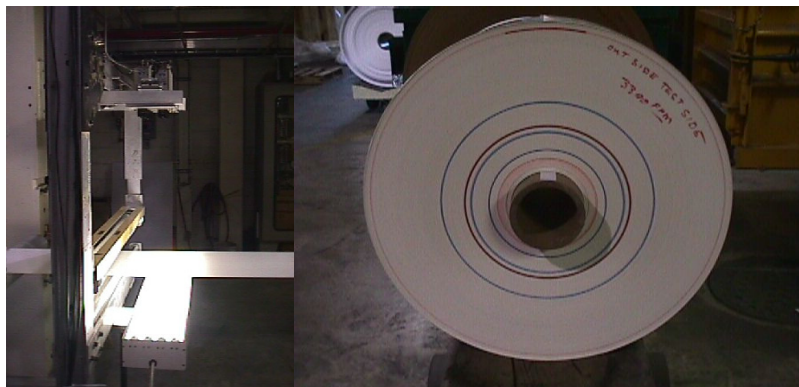
**Figure 32 – View of inspection assembly during run and a picture of the Accolade Gloss Roll with defect location marks.**

The test data and evaluation indicated that the unit was setup correctly and no apparent adjustments were required or performed. The defection threshold for activation of streak defects was set at <0.4 volts for narrow, 0.4 volts to 1.2 volts for medium and 1.2 volts for large. The unit indicated streak detection and was verified not only by the systems software, but by a small Sony TV monitor that is included with part of the unit for visualization. Additionally observed by IPST and RKB personnel were additional streaks that appeared to come and go quite frequently. These signals appeared to move right and left along the cross direction of the web. These scratches appeared on both sides of the web. The characteristics of the scratches were such that reflected light most likely would be required for more consistent pick up. The wider and more apparent streaks were observed by IPST, Appleton and RKB personnel and were visually verified via the TV monitor, data logging and by the oscilloscope. The roll of paper was marked upon detection of the large coating scratches with blue ink on the side of the web indicating location (Figure 32).

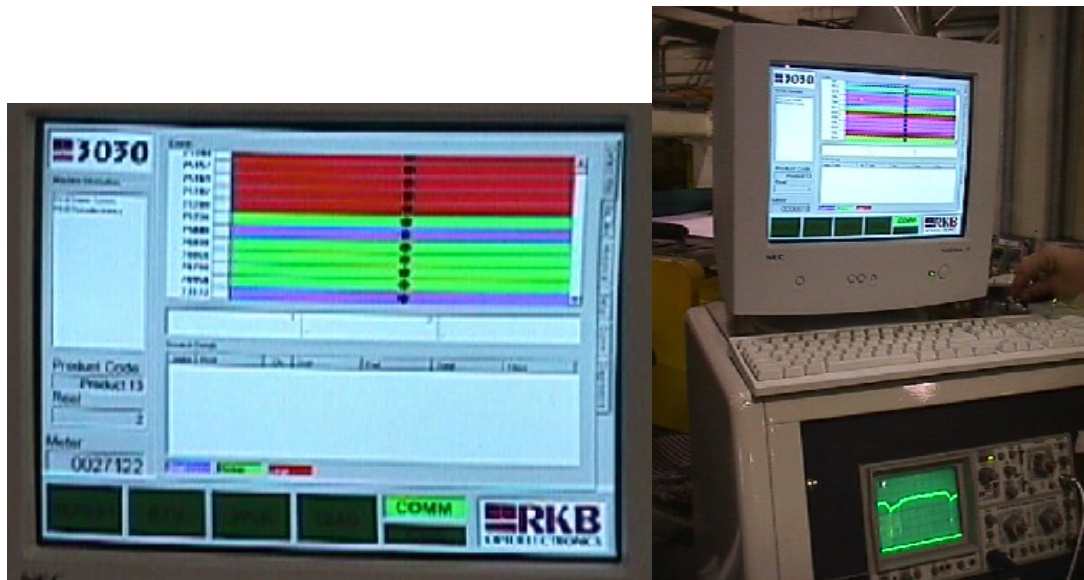
**Figure 33 - View of cabinet and CRT screen during trial with calibrated defects. Each Red strip indicates a large size defect, Green medium and Blue small.**

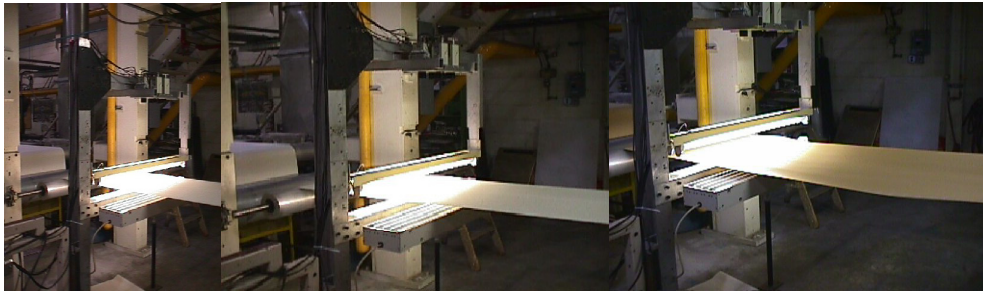
**Figure 34 - Showing the web sagging problem during the Newsprint A trial run that contributed to web breaks.**

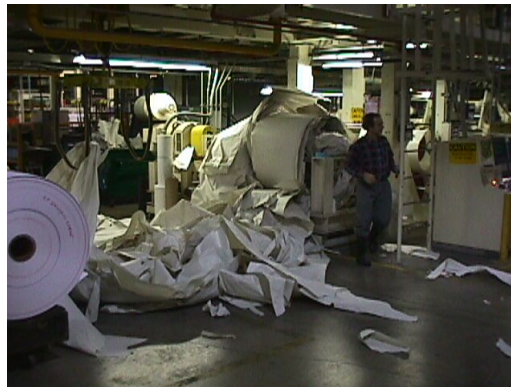
After some adjustments we were finally able to reach 5000 fpm (000 m/min) and start acquiring data. Then after five seconds of data acquisition at 5000 fpm the web directional control couldn't respond fast enough. A web break occurred that caused a huge paper Jam (Figure 35). A long section of the roll was lost and the roll was split into two rolls with the smallest roll not negligible in diameter. Both rolls were removed from the machine.

**Figure 25 - Web Break of Newsprint Roll A**

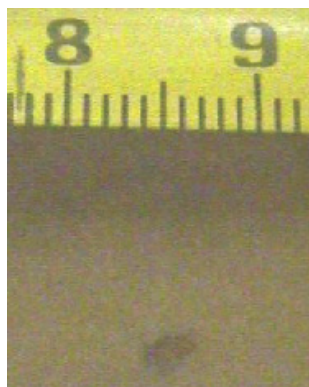
That data collected (Table 29 above) was favorable according to the settings and conditions. The web exhibited quite a lot of sagging and flutter, which affects the detection capability as the web significantly moved in and out of focus to the sensor. This problem may have been caused by mechanical problems in the pilot machine during the break problems the day before when operational speed was running up to 5000 fpm (000 m/min). The outside surface of the web was facing up towards the sensors. During this test, the footage module was not connected so it was not possible to know exactly the location of the defects in the web. However, the defect count overall was not affected nor was defect detection. Figure 36 depicts a defect that was detected during this trial run. The divisional ruler used was in metric and divided by centimeters. Each graduation represented a millimeter. The spot defect was approximately 3 to 4 millimeters diameter.

**Figure 26 - Picture of spot defect detected during linerboard import test run**

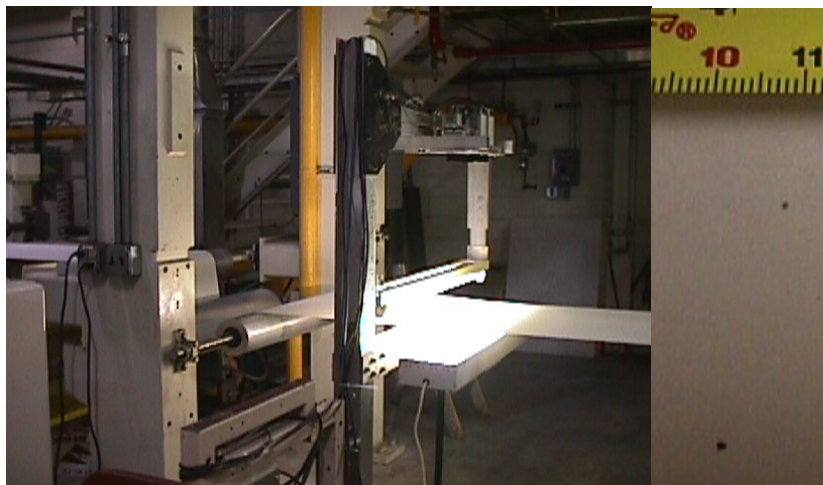
**Figure 38 - View of frame during the trial with Newsprint roll A and defects on newsprint.**

In this trial run, a lower speed was deliberately used as to avoid continual web break problems. Contrarily to Thursday, the CD position of the web was much better controlled because of some new adjustment made on the pilot coater by operational staff. Below are two photos (Figure 38) depicting the newsprint web again, sagging during the run and a picture of defects actually detected and marked for verification. The divisional ruler used was in metric and divided into centimeter with the small graduations representing millimeters. As seen in the photograph of the defects, the defects were approximately 1 millimeter diameter or larger. This is significant as it does correlate to the sizing set by the RKB operational software program and showed correct sizing and classification during detection.

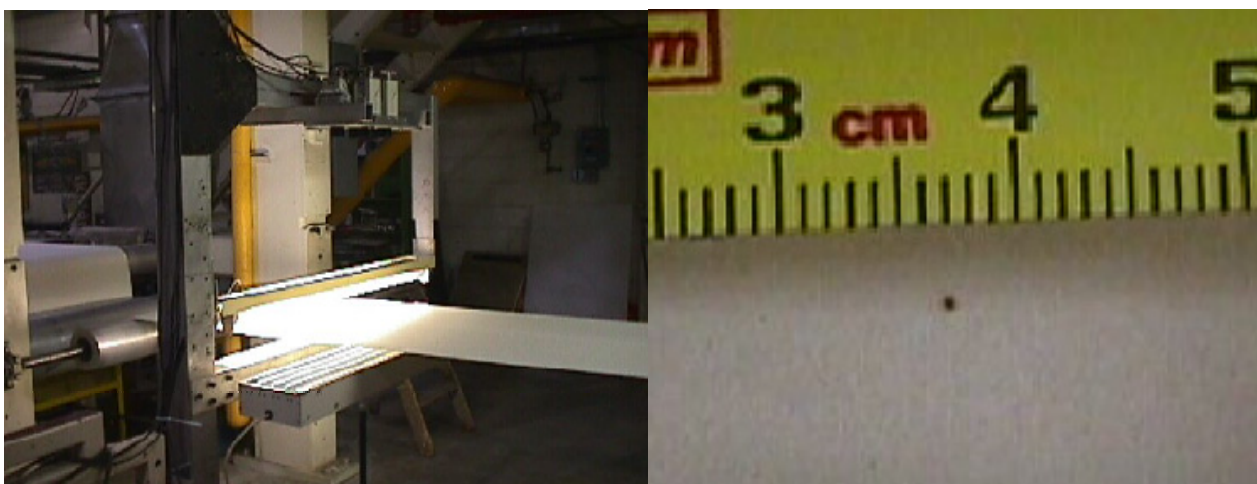
**Figure 39 - Camera frame during testing of Newsprint Roll B and a spot defect detected during the run.**

Acquisition of data occurred between the 2<sup>nd</sup> red mark and the black mark (1<sup>st</sup> red mark was when the coater reached maximum speed of 3500 fpm) at a constant speed of 5000 fpm. No web breaks occurred and the test was completed up to the end at 5000 fpm without any noticeable pilot machine problems. Data files are currently being processed and analyzed. Figure 39 shows the equipment and a spot defect detected during this run.

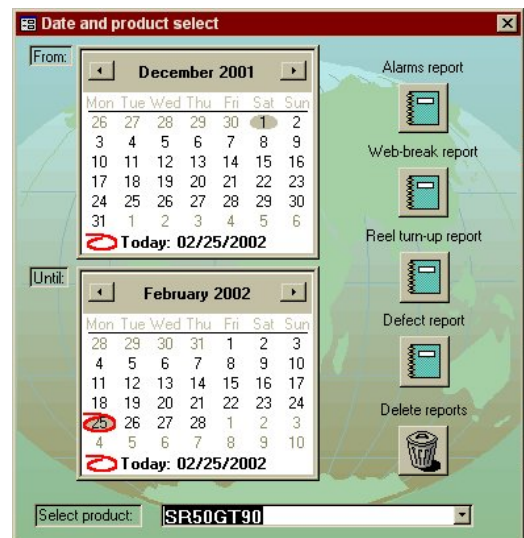
Figure 54 – Historical Information Archive

Some examples of RKB's QAMS Historical Information Reporting Functions are as follows:
